Manhole Inspection Summary

Manhole # S67Y__004MH

Location Address: **6300 Beckley St.**

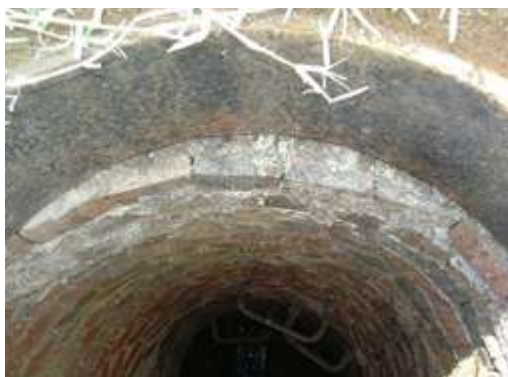
Defect 2

Frame Offset: **1.5** (in.) Condition: ☒ Sound ☐ Cracked ☐ Leaks

frame offset

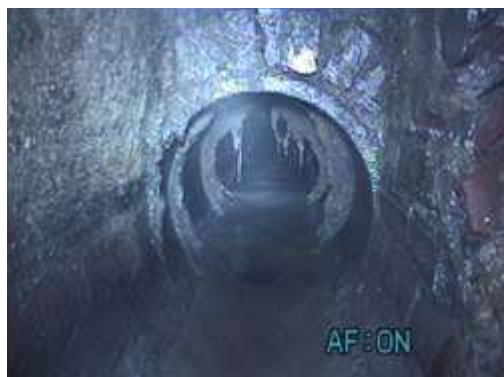
Defect 3

deposits attached grease 8:00-5:00 25%
incoming 6 o'clock

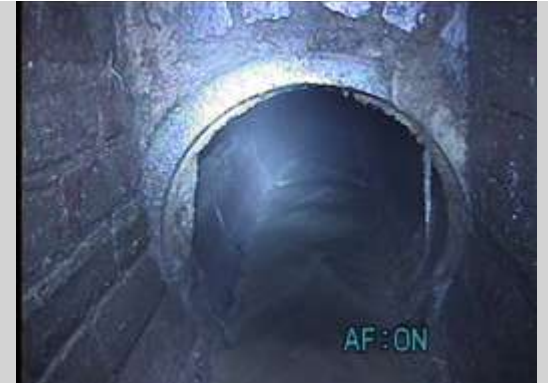
12 O'Clock Outflow

15 in. Circular Gravity Sewer
Pipe Out @ 12 O'Clock

Pipe Height: **15.6** (in.) Rod and Bar (Angled)
Pipe Material: **Clay** ☐ Pipe Lined
Invert Depth: **16.08** (ft.) Flow Characteristics: **Fast**
Deposits: ☒ None ☐ Mud ☐ **Gravy** ☐ Debris ☐ Grease
Silt Depth: (in.) Deposits Extent:
Infiltration: **None** Pipe Seal Cond: **Sound**

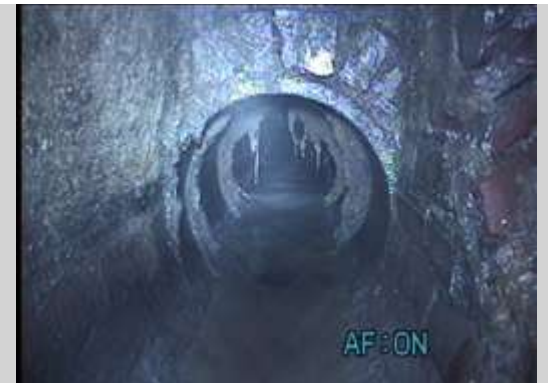
6 O'Clock Inflow

15 in. Circular Gravity Sewer
Pipe In @ 6 O'Clock

Pipe Height: **15.6** (in.) Rod and Bar (Angled)
Pipe Material: **Clay** ☐ Pipe Lined
Invert Depth: **16.00** (ft.) Flow Characteristics: **Fast**
Deposits: ☐ None ☐ Mud ☒ **Gravy** ☐ Debris ☐ Grease
Silt Depth: **0.5** (in.) Deposits Extent: **Light**
Infiltration: **Evidence** Pipe Seal Cond: **Sound**
